# Analysis of Lightning-Caused Distribution Transformer Failures in Ghana\*

<sup>1</sup>S. Nunoo and <sup>2</sup>A. E. Sey

Nunoo, S. and Sey, A. E. (2018), "Analysis of Lightning-Caused Distribution Transformer Failures in Ghana", *Ghana Journal of Technology*, Vol. 3, No. 1, pp. 9 - 16.

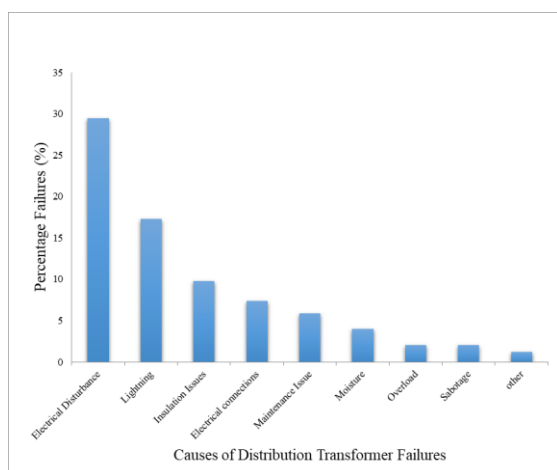
**Fig. 2 Distribution Transformer Failure Modes**

According to the Electricity Company of Ghana (ECG), Western Region is leading in terms of lightning-caused distribution transformer failures in its distribution system. The claim is consistent with a study conducted by William Bartley in 1998 at Siemens (Germany) that classified mode of distribution transformer failures and found that lightning contributed 17.32% of the distribution transformer failures (Taylor and Alehosseini, 2015). The results of that study are shown in Fig. 2, which shows the percentage distribution to the distribution transformer failures to the cause of the failure.

Lightning surges and insulation failures are identified as the major causes of transformer burnouts. For 2013-2015, failure due to lightning surges and insulation failure are equal in magnitude; each contributed 29% to PMT failures. Similarly, overloading and short-circuit failure occurrences also contributed about 13% and 15%, respectively, over the same period. Here, the term “others” are used to classify uncommon causes, such as moisture ingress, sea effects (especially transformers mounted in coastal areas), transformer explosion, etc. This also contributed 12% of failure over the same period.

For 2013-2015, GMT failure was mostly as a result of insulation failure, followed by lightning surges, i.e., 32% and 28%, respectively. Overloading also contributed 14% of the total GMT failures, whereas short-circuit is attributed for 13% of the failures over the same period with others resulting in 13% of the GMT failures.

For 2011-2012, lightning surges was the leading cause of PMT failures, followed by insulation failures, contributing 39% and 23%, respectively. Others contributed 16% of the PMT failures, short-circuit destroying 13% and overloading also destroying 9% of the transformers over the same period. Similarly, in the case of GMTs, lightning surges is the major cause of failure, followed by insulation failures, contributing 38% and 29%, respectively. Overloading also destroyed 13% of the GMTs, others recorded 11% of the burnouts, with short-circuit destroying 9%.

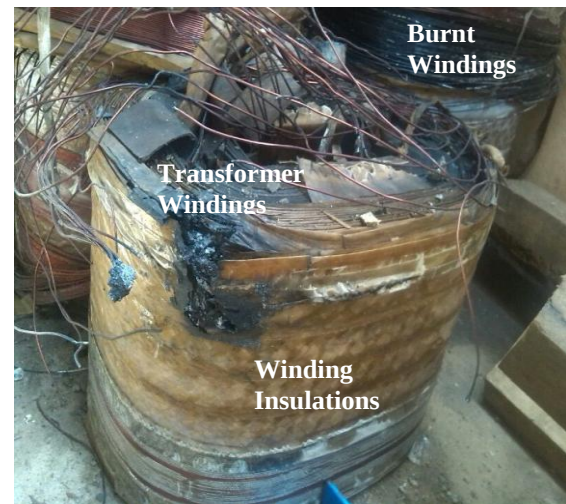
**Fig. 3 Transformers Windings due to Lightning**

When lightning surge enters the secondary side of a transformer, large line and phase voltage occurs at the layer closer to the neutral terminal; nearly 62% of the incident surge voltage is taken up on the first turns. Possibility of breakdown at this point is high. Surges entering the transformer from the LV side may, on occasions, allow damage to occur on the HV winding or the LV winding or on both.

At the laboratory, 3 kV surge was injected into a transformer from the LV side. With HV/LV windings of 11 kV/240 V, the turns ratio was 45.8 to 1. The 3 kV is “stepped-up” to a prospective 137.4 kV in the HV winding and this exceeds the standard of 95 kV of the basic insulation level. This transformer failed instantly, as shown in Fig. 3.

- (i) Damage at layer closer to the neutral terminal;
- (ii) Discharge spots occur around secondary bushing; and
- (iii) Dielectric strength of oil is often good.

A suitable application of a surge diverter can minimise the overvoltage effect caused by lightning surges.

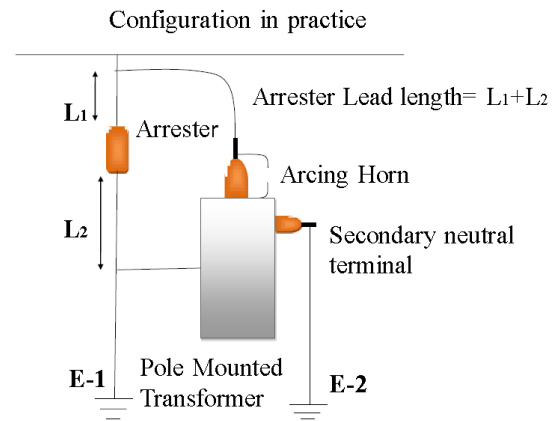
**Fig. 4 Existing Protection System for Lightning-Related Surges on Distribution Transformers of ECG**

Fig. 4 shows the existing protection system and Fig. 5 shows the proposed transformer protection system, where improved capacitors have been installed at both ends of the distribution transformer. The proposed protection system is installed parallel to both the HV and LV terminals of the distribution transformer. Moreover, Medium Voltage (MV) surge arresters are installed at the HV terminals of the distribution transformer. Field experience has shown that if only MV surge arresters are installed, without a surge protection device at the LV side, then the peak of the overvoltage arising at or transferred to the LV side of the distribution transformer may exceed the corresponding insulation level. The simultaneous installation of MV surge arresters at the HV side and surge protection device at the LV side significantly reduces the LV side overvoltage.

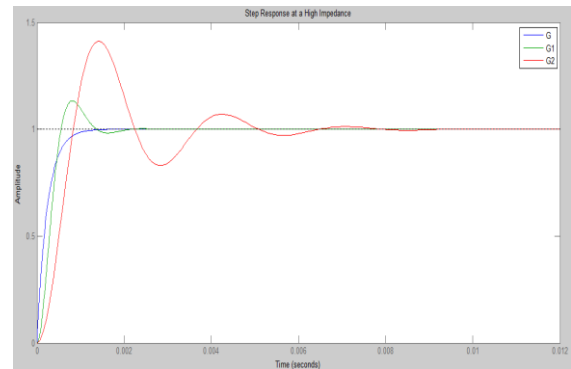
**Fig. 7 Comparison of Step Responses at High Ground Resistance**

The Fig. 7 shows the step response of the transfer function given in Equation (3) for the three setup scenarios in Table 3. G (Setup 1) represents the transformer performance at normal operating conditions. In this case the charge capacitance between the clouds and the transformer is zero ( $C = 0$ ), therefore there is a smooth rise of the voltage magnitude in per unit to the steady state operating conditions. The transformer continues to operate in steady state so long as there is a normal operating

It is realised from the Fig. 7 that there is no effect on the distribution transformer as indicated by the blue coloured G and since at that condition there is also no lightning strike. G1 (Setup 2) represent the step response at low lightning strike while G2 (Setup 3) represent the step response at high lightning strike.

But at G1 the lightning transient surge occurred in the system for long and caused under-damp which leads to a very high probability of causing transformer destruction.

Condition at G2 will definitely destroy the transformer because the arrestor is not able to protect the system. There was a very high peak value at this condition and it occurred for a long time in the system. This means a better protection is required to alleviate this condition.

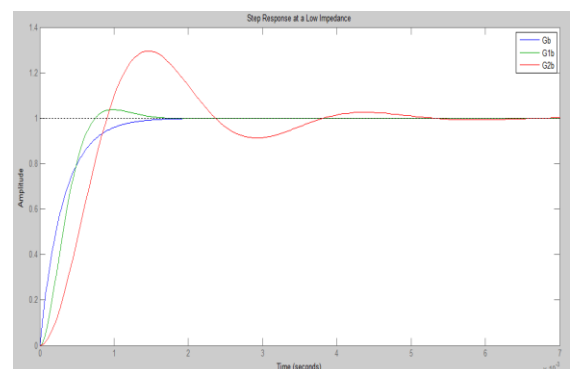
**Fig. 8 Step Responses at Low Arrester Impedance**

The protection offered by the arrester is also crucial as a high impedance of the arrester due to improper connection or inappropriate earthing can lead to the destruction of the distribution transformer. The

When additional surge protectors are introduced such that the ground resistance reduces from  $1\ \Omega$  to  $0.8\ \Omega$ , then the system in Fig. 8 becomes better as compared to Fig. 7. The arrestor was able to alleviate the under-damp (sag) of the G1b so in this case there will be a transient although but it has no effect on the transformer. Although the nature of the strike is so high in the case of G2b, there may be a reduction in the severity of destruction of the distribution transformer and this is due to the low impedance of the arrestor circuit. The transient condition did not occur for a very long time and also the peak transient voltage has been reduced.
