Structure Integrity Assessment of a Cocoa Liquor Plant in Ghana*

Simons, A., and Addy, C. (2019), "Structure Integrity Assessment of a Cocoa Liquor Plant in Ghana", *Ghana Journal of Technology*, Vol. 4, No. 1, pp. 1 - 6.

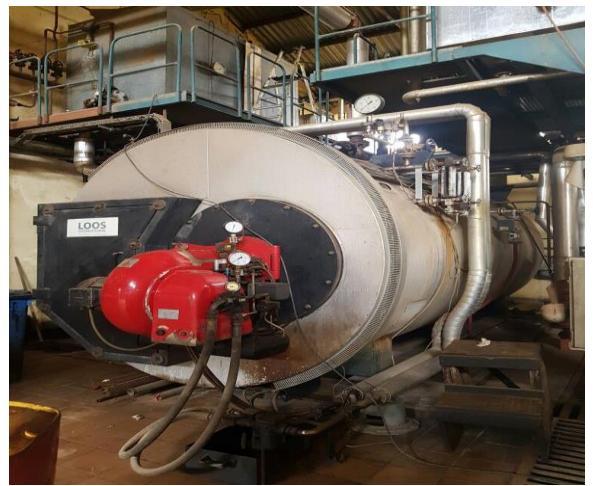
The boiler and roasters were in good conditions as shown in Fig 2 and Fig 3. The forwarding pumps for the Cooling Tower were not mounted on their skids which secure the pump and the motor firmly to the foundation to allow for their smooth operation. The absence of skids in the assembly could lead to misalignment in bearings and couplings of the pump due to vibratory motion. One of the pumps was found lying close to the skid (Fig: 4), and, it was not functioning. It was found that the skids were not in place as a result of the frail nature of the bolts and nuts holding the pumps to the skids. Fig. 5 shows spaces meant for mounting of fans and four of such fans were in place. Three chiller condensers were inspected.

Fig. 2 Boiler

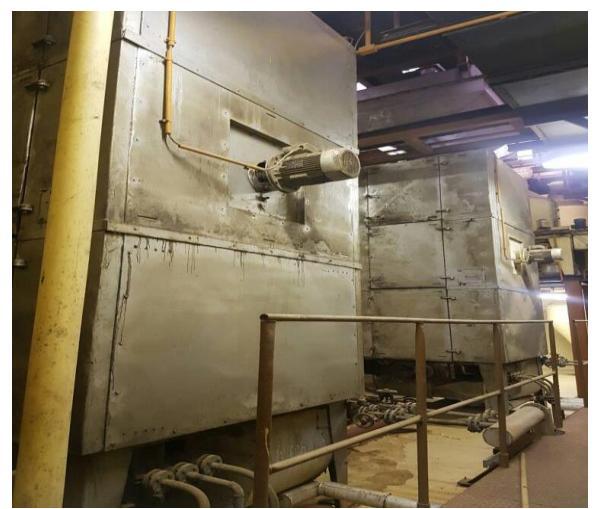
Fig. 3 Beans roasters

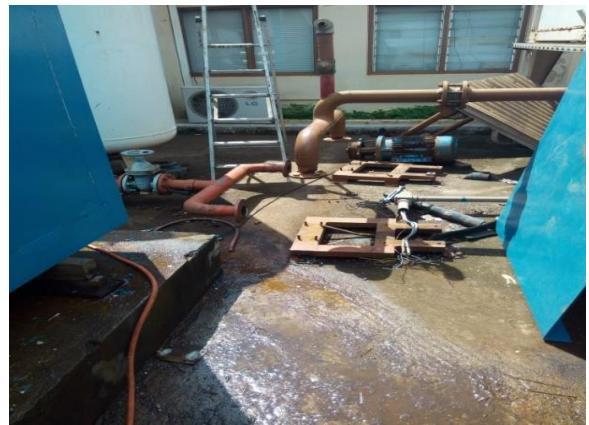
Fig. 4 Pumps Skid

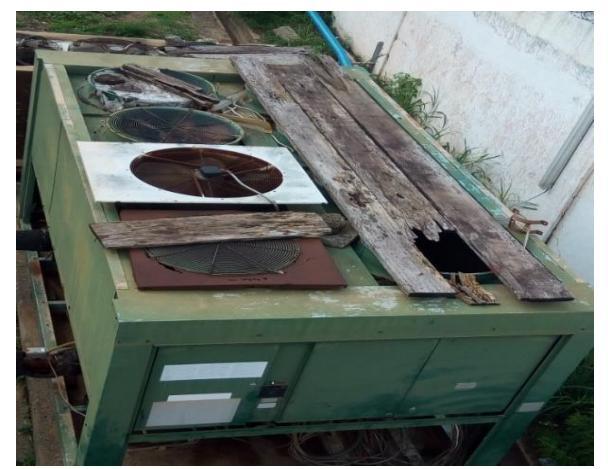
Fig. 5 Structure for mounting of Fans

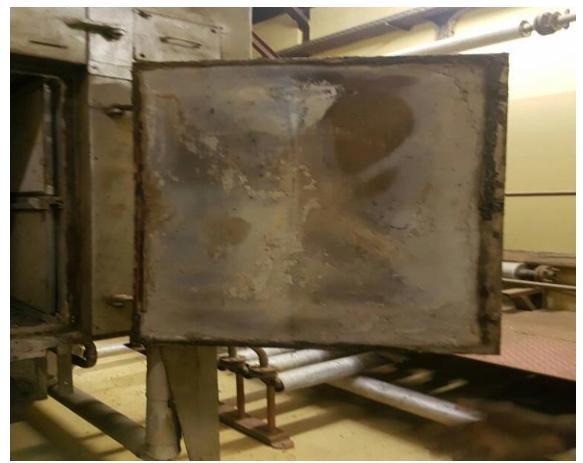
Fig. 6 portrays the rubber seals on the roaster doors which are hardened and peeling off. Roaster door rubber seals hold the doors firmly to the cabin of the roaster once closed. Worn out seals meant the roaster cabin door cannot be shut. The situation is undesirable since the preparation of cocoa liquor requires having the beans in the right state for an excellent blend. Thus, roasting is done to dehusk the beans, sterilize and develop for the right flavour. Therefore, the proper functioning of the beans roaster means a quality blend from the factory, hence, the roaster has to be in perfect shape for production. Due to the long absence in plant operation, the beans roasters after visual inspection were found to have decolourised with some level of rust on the roasters.

Fig. 6 Seals peeling off Roaster Door

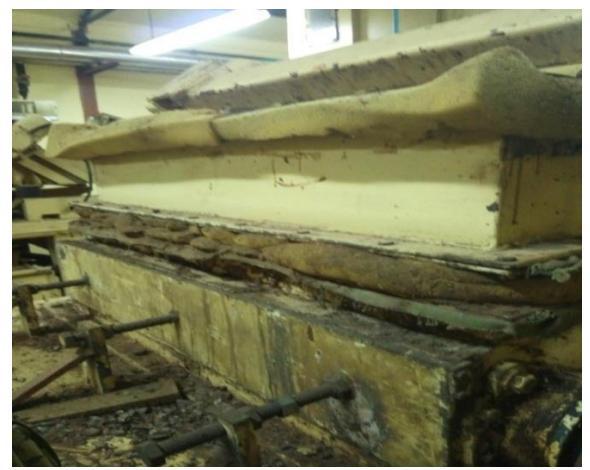
The team observed that foams have been used to seal the openings of the winnower crusher instead of the required tarpaulin-like material (Fig 7). The winnower is very essential in the initial process of the beans refinement in the entire cocoa liquor production processes. Winnowing is done to separate the hay of the cocoa beans from its fruit after crushing of the beans. The operation of the winnower is based on agitation which enables the smooth separation, these agitations results in vibrations. These vibrations have led to the removal

of the bolts and nuts holding the winnower to the base and have further damaged the winnower rubber seals interfacing between the winnower and the base.

Fig. 7 Winnower Crusher seals

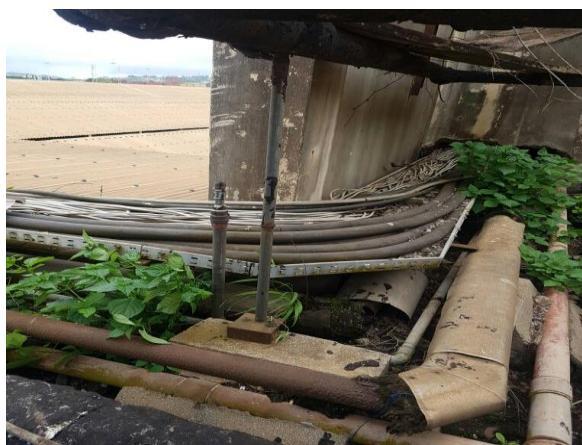
All the controls were in good shape, however, they were covered with dust. The cables and trays were covered with a lot of dust which needs to be cleaned. Cables around the cooling tower have been exposed to harsh weather conditions for long, to the extent that the colour of the outer sheath has changed (Fig. 8). In industrial settings such as a cocoa liquor plant where heavy equipments such as boilers and roasters are used; it is certain that heavy duty electrical cables would used. Due to the high voltage ratings of those cables it is essential to store them safely. For electrical safety, the cable tray system is encouraged for industrial setups. This system helps save space, material and cost; and makes it easy for maintenance and extension of cable tray installation (Anon., 2009). It was observed that the tray system was in place, howbeit, the tray was not covered, hence exposing the cables to the harsh weather conditions. In spite of the fact that most cables are designed to function at specific temperature

conditions, prolonged exposure to high temperatures will damage them. Research findings from Mani, S *et al* (Mani *et al.*, 2018) suggest that there is a limit of the thermal tolerance of each cable hence if exceeded deteriorates the insulation sheath around the cable and puts the system at risk of fire outbreak; there is the need for total burial of the cables to avoid human contact. The 1000 kVA generator was found to be operating below it rated capacity at an estimated 40% amounting to 400 kVA. The level transmitter was found wornout and suspected to be defective and some switches were also found broken.

Fig. 8 Cables exposed to harsh Weather Conditions

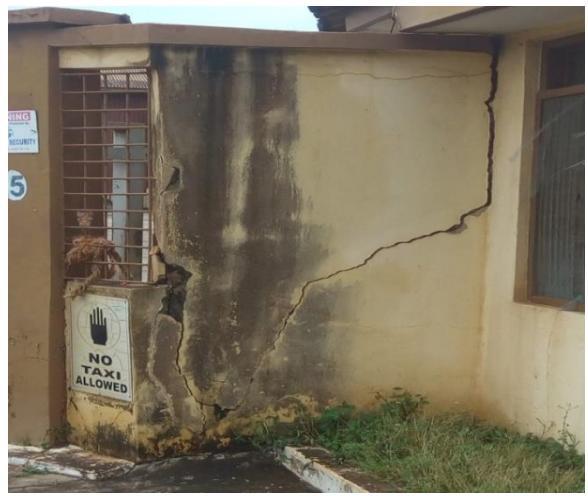
The main entrance to the factory possesses a serious threat to both workers and passers-by. The entrance walls have developed some cracks and appear weak. According to Kunal and Killemsetty (2014), cracks usually result when the prevailing stress on the building exceeds the designed strength of the building. This stress is classified into two types namely, externally applied stress and internally induced stress. The externally induced stress includes dead, live, wind or seismic loads, whilst the internally induced stress is due to thermal variations, moisture changes and chemical actions (Kunal and Killemsetty, 2014). During the inspection cracks were observed at certain parts of the building, the cracks were seen to be growing in thickness and in depth. Based on the gap classifications of Kunal and Killemsetty(2014), the crack can be classified as medium crack.

Fig. 9 Crack at the Main Entrance

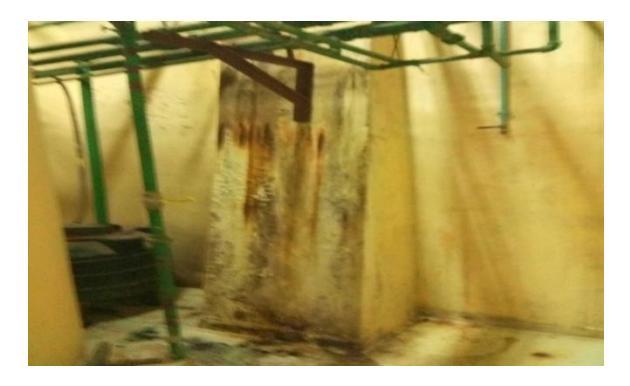
There were two types of leakages observed during the inspection; water and oil. Leakages were observed from the roof into buildings spaces as a result of chocked gutters on the roof. These could be attributed to the non-maintenance of drainage for rainwater, open penetration which could be vents for pipes or chimneys, and aged roof (Moore, 2019). A critical look at the roofing system pointed to aged roofing system to be the principal cause of the leakages. This can result in electric shocks taken congnisance of the fact that the plant has a lot of electrical connections and life threatening. There is also the possibility of rusting of wall mounted frames and peeling off of wall coatings (Fig. 10).

Fig. 10 Leakage of Water Causing the Painting of the Tempering Room to Peel Off

II.	An immediate rust control action should be carried out to curtail the rapid deterioration of the cooling tower and the fuel tank roof.
General housekeeping	I.	 An immediate housekeeping should be carried out at the following areas; (a) Boiler house (b) Chiller room (c) Beneath the fuel tanks (d) Areas around the cooling tower
	II.	Also, Check and repaint deteriorated painting peeling from the wall of the buildings to maintain good housekeeping

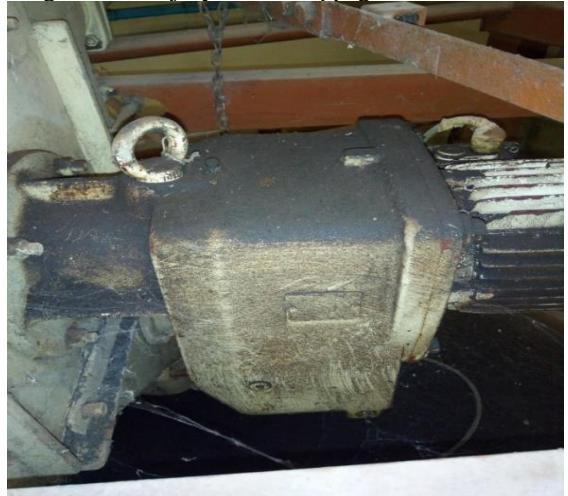
Concerning the oil leakages, it was observed that the gearboxes for the tubular drag conveyors leak badly as well as the hydraulic unit for the cooler and this can be seen in Fig 11 and Fig 12. This is as a result of aged seals and/or gaskets in the unit. According to Gawande, (2019), the seal performance of gearbox flange assembles has direct correlation with the selection of the right gasket thickness of the gearbox. Ensuing from the prevailing conditions,

Fig. 11 Tubular Drag Conveyor Gearbox

these gaskets need replacement to avoid damage to the gears and injury due to slippage.

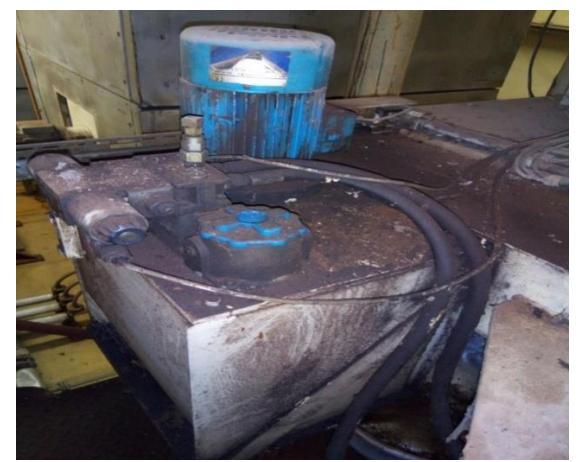
Fig. 12 Cooler Hydraulic Unit

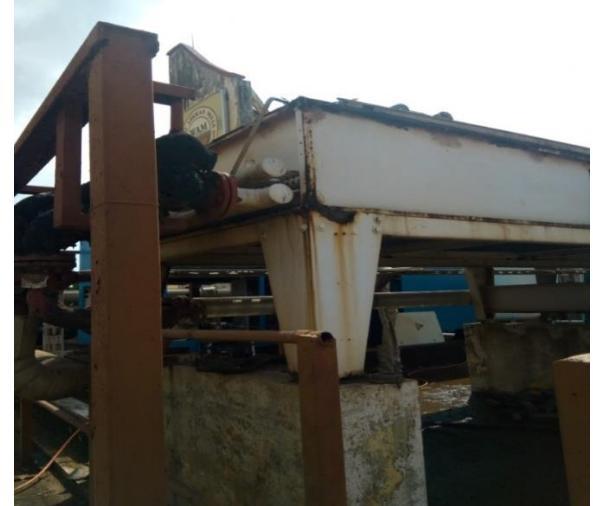
One of the critical observations made was on the issues of rust. It was found that the structure of the cooling tower had been attacked by rust (Fig 13). An impeller of one of the cooling pumps which was on the skid was found rusted. The fuel tank that serves the plant was found in a deplorable state, in fact the roof was totally rusted (Fig 14) and put workers at risk when working with such structures (Singhania and Sanyal, 2013).

Fig. 13 Rusted Cooling Tower
