# Using Photogrammetric Methods for Mapping Geological Structures and Predicting Pitwall Kinematics at the Perseus Mine, Ayanfuri of Ghana\*

Affam, M. and Baffoe, P. E. (2020), "Using Photogrammetric Methods for Mapping Geological Structures and Predicting Pitwall Kinematics at the Perseus Mine, Ayanfuri of Ghana", *Ghana Journal of Technology*, Vol. 4, No. 2, pp. 66 - 79.

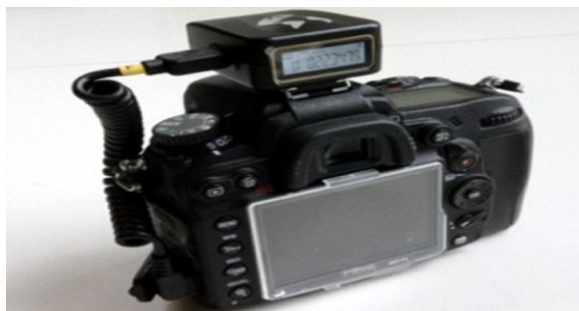
An off-the-shelf single-lens reflex (SLR) digital camera, Nikon D7000, with the lens of focal length 60 mm was used; it mounted on a tripod before taking the photographs. The resolution can be achieved at a range between up to 2 000 m and is shown in Fig. 2.

**Fig. 2 Nikon D7000 Camera**

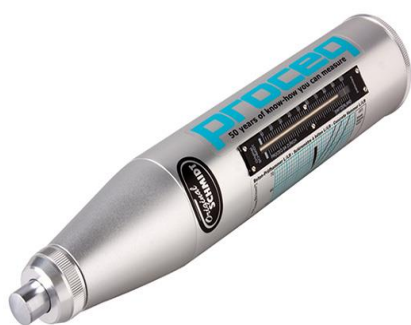
In addition, Schmidt Hammer was used in measuring the strength of the rock. In measuring the strength, there was the need to measure both the perpendicular and the horizontal strengths and the average taken as shown in Fig. 3.

**Fig. 3 Schmidt Hammer**

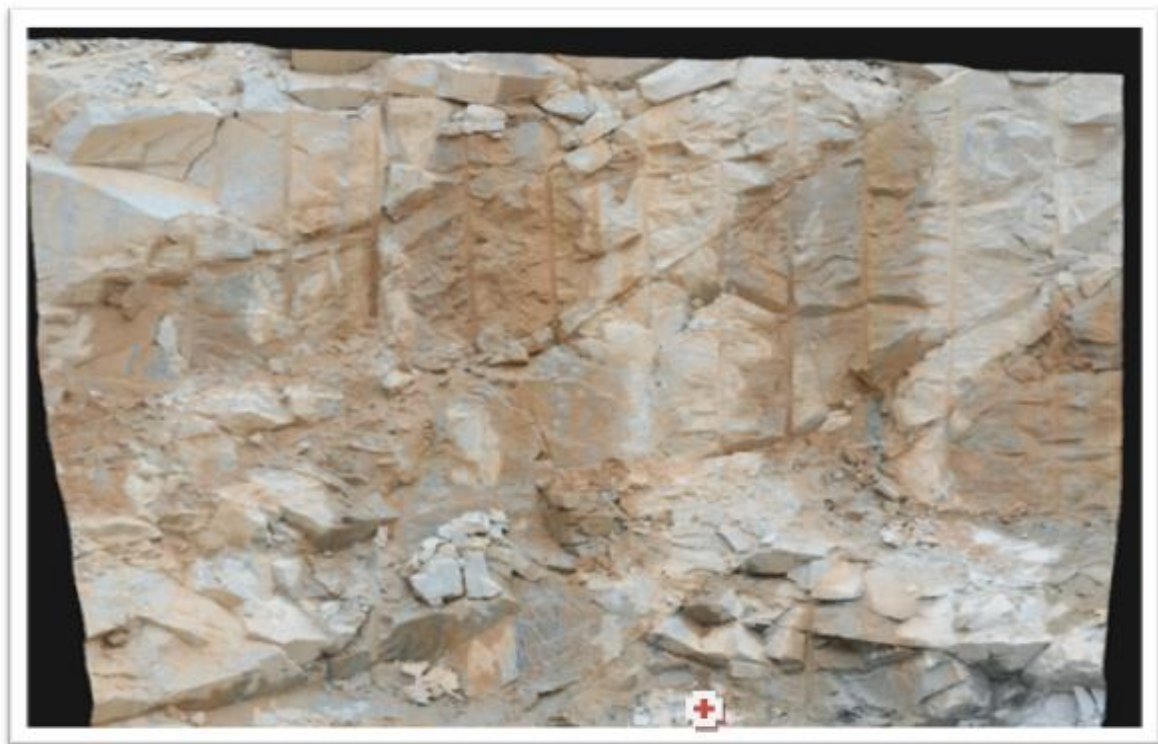
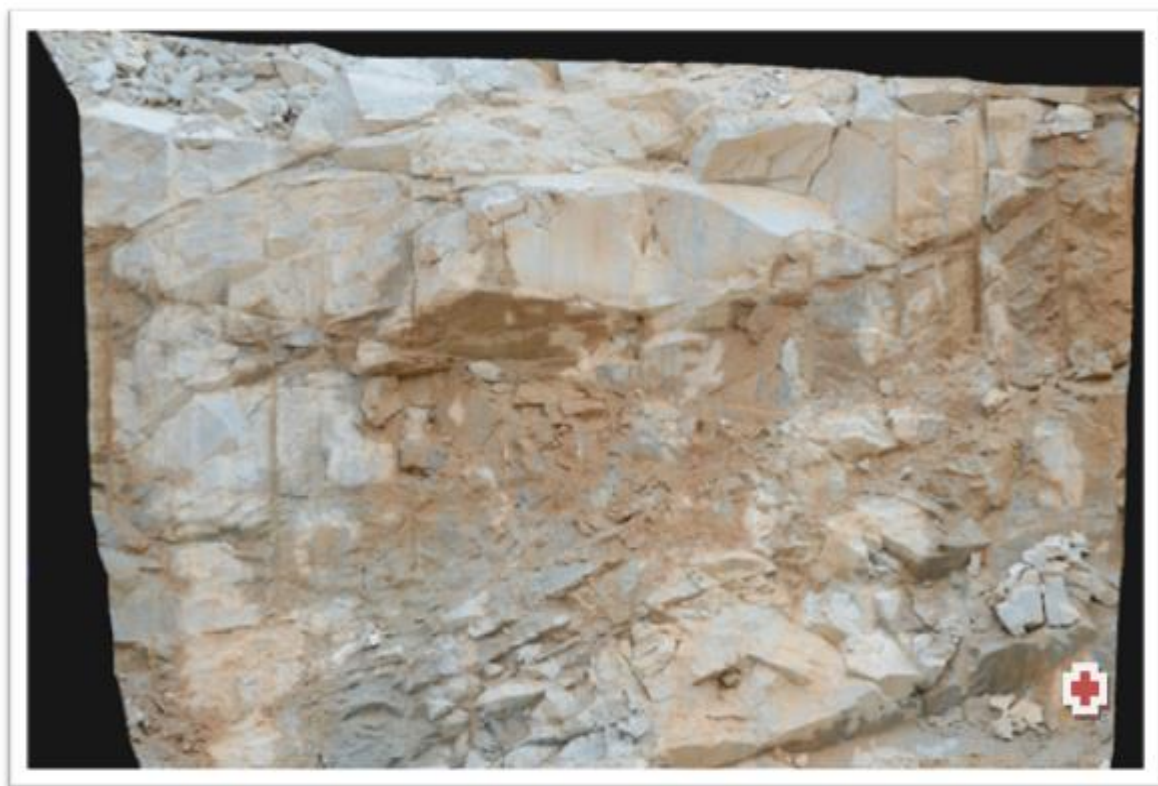
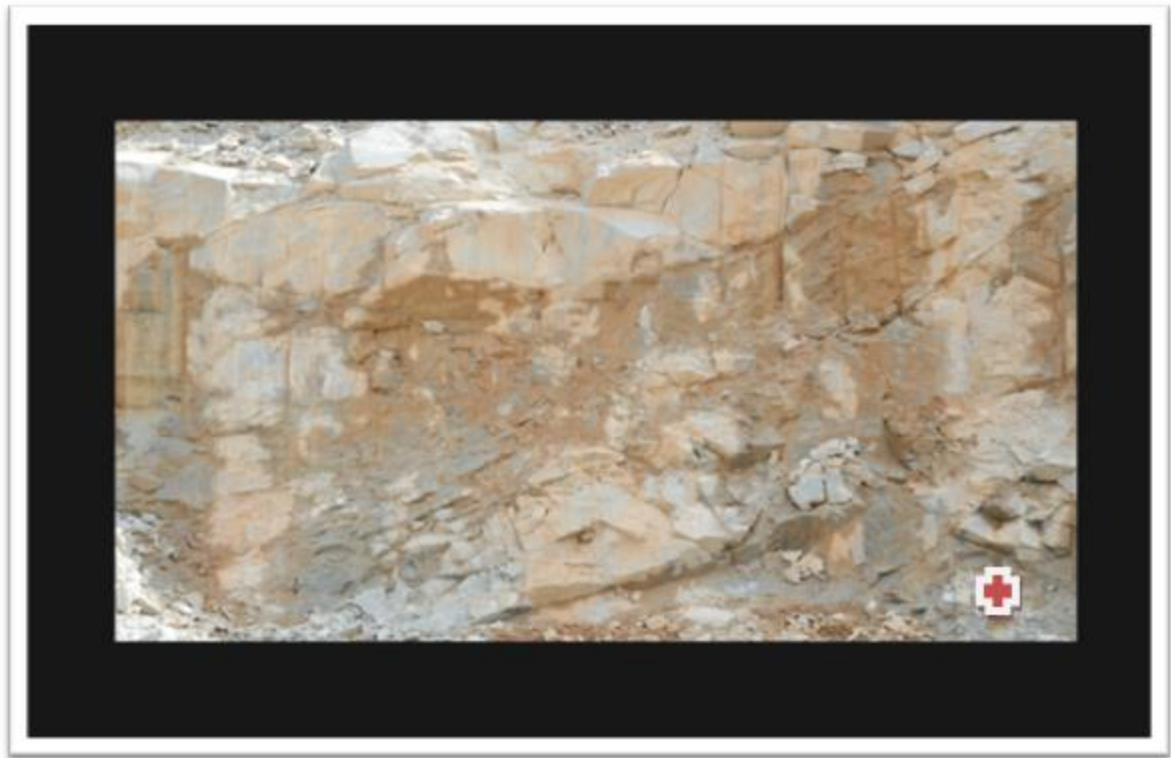
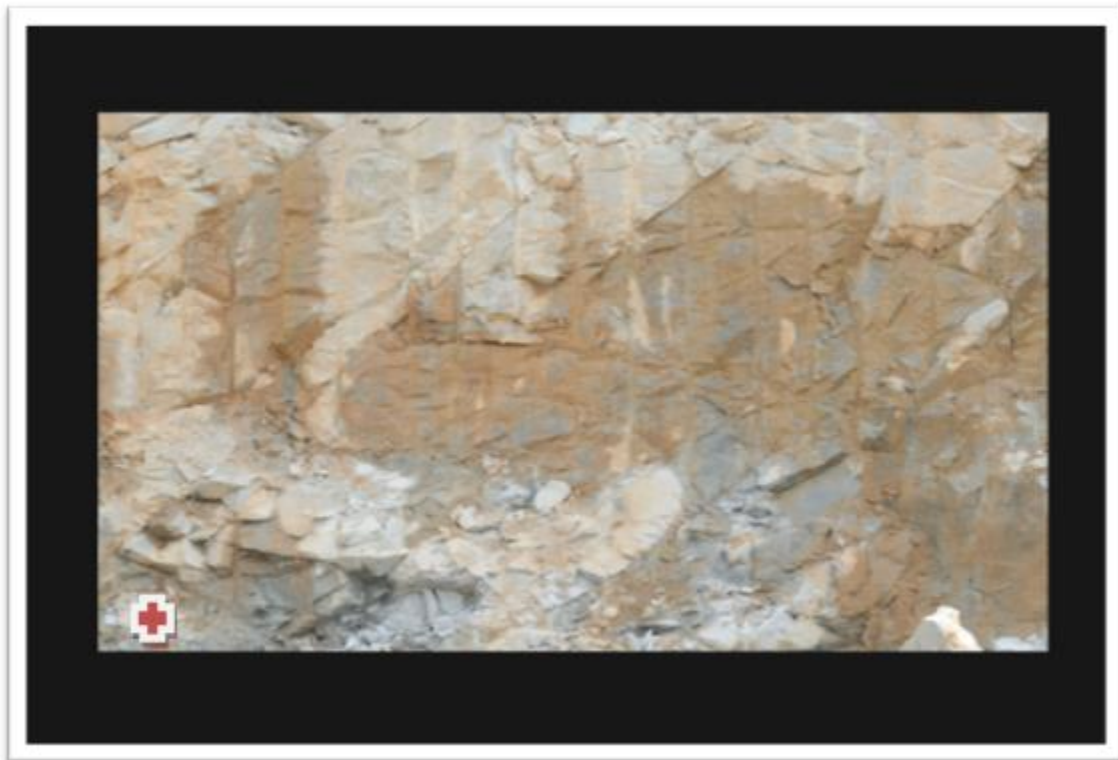
The photographs taken are presented in Figs. 5 to 10. The images were taken in series, left, central and right. The first central image was taken containing the control point when stood on the left base station (FCL) and this is as seen in Fig. 5. Also, the image taken from the first central containing the control point when stood on the right base station (FCR) as in Fig. 6. The second left image containing the control point was taken when the camera was set on the left base station (SLL) as seen in Fig. 7. The third right image containing the control point was also

taken when the camera was set on the left base station (TRL) as shown in Figs. 8-9. The second left image containing the control point was also taken when the camera was set on the right base station (SLR) as shown in Fig. 10. Then the third right image containing the control point was taken when the camera was set on the right control (TRR) as shown in Fig. 11.

**Fig. 5 First Central Image Containing the Control Point when Stood on the Left Control (FCL)**

**Fig. 6 Second Left Image Containing the Control Point when Stood on the Left Control (SLL)**

**Fig. 7 Third Right Image Containing the Control Point when Stood on the Left Control (TRL)**

**Fig. 8 First Central Image Containing the Control Point when Stood on the Right Control (FCR)**

**Fig. 9 Second Left Image Containing the Control Point when Stood on the Right Control (SLR)**

**Fig. 10 Third Right Image Containing the Control Point when Stood on the Right Control (TRR)**

Mosaic is the pattern of putting pieces of pictures together to form one image. From Fig. 5 to Fig. 10, a mosaic was formed by combining FCL and FCR images, SLL and SLR images and TRL together with TRR images. In all, three (3) individual mosaics were formed. The three mosaics were combined to form a composite image as seen in Fig. 11.
